**FRENCH RIVER BASIN  
DUDLEY, MASSACHUSETTS.**

**LARNER POND DAM  
MA 00111**

# **PHASE I INSPECTION REPORT NATIONAL DAM INSPECTION PROGRAM**

**AUGUST, 1978**

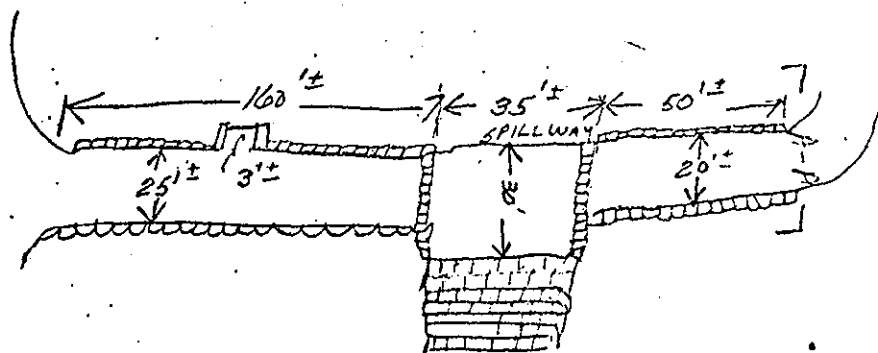
A-A END VIEW DAM

STONE MASONRY WALLS W/ EARTH FILL  
3 GATE OPEN CANNOT SEE ANY BOARDS. WATER 1'±  
BELOW GOING OVER SPILLWAY. SPILLWAY WALLS 18" ABOVE  
SPILLWAY.  
 Sketch (Not to Scale):
